Re: DJ #90-5-1-1-11394 — SSER Work Plan Deliverable for review by EPA and TDEC

The Hamilton County WWTA completed a draft deliverable titled *Sanitary Sewer Evaluation/Rehabilitation (“SSER”) Work Plan* in accordance with the Consent Decree entered into by the United States District Court for the Eastern District of Tennessee (Southern Division); Case No. 1:23-cv-00225. As set forth in Paragraph 22 of the Consent Decree, the *SSER Work Plan* shall be submitted to EPA and TDEC for review and approval no later than thirteen (13) months after the effective date.

Pursuant to the Consent Decree, the *SSER Work Plan* provides for the continual assessment, analysis, and rehabilitation of the entire Wastewater Collection and Transmission System (“WCTS”). This SSER Work Plan will establish the procedures for setting priorities and expeditious schedules for undertaking the WCTS assessment and rehabilitation throughout the duration of the Consent Decree. This document will determine how WWTA will assess, analyze, and rehabilitate the WCTS infrastructure to, among other things, reduce Inflow and Infiltration (“I/I”), eliminate structural defects, and other conditions causing, or that are lik

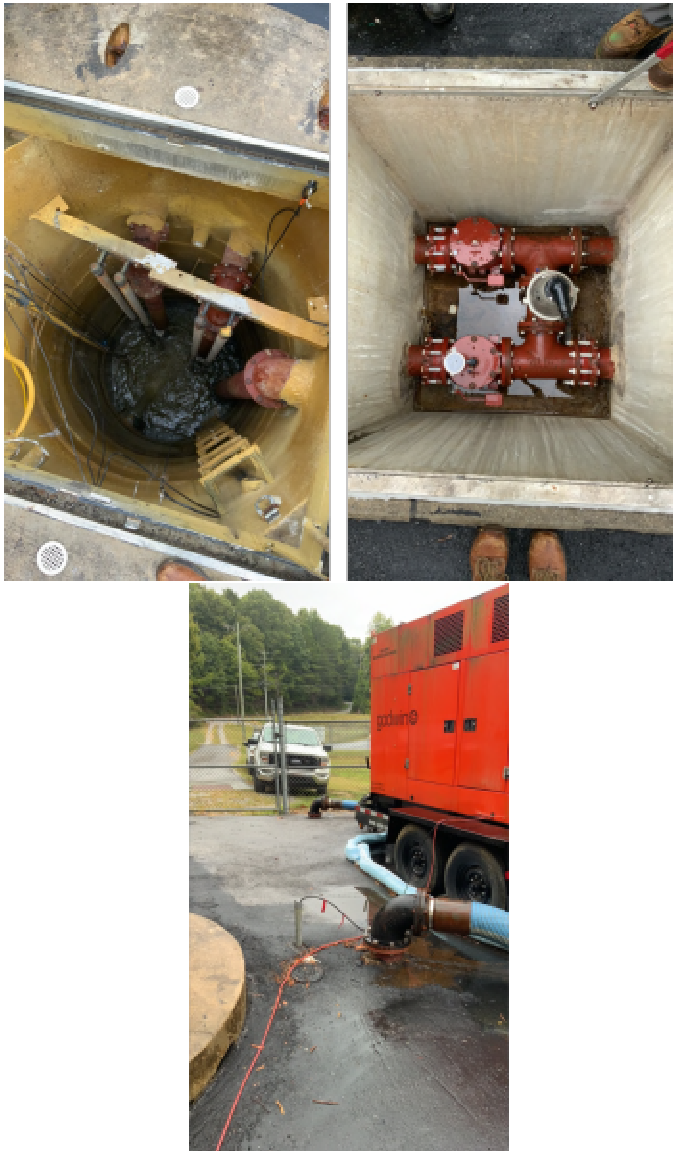
Structural/Mechanical Photos

Number of Pumps: 2	VV Supports/Guide Rails: No Defects
Pump Condition: No Defects	Onsite Water: Yes
WW Discharge Piping: No Defects	Water Working?:
WW Supports/Guide Rails: No Defects	Hose Bib Provided?: Yes
Valve Condition: Accessible, Working	Washdown Pad?: Yes
VV Discharge Piping: No Defects	Backflow Preventer?:
Overall Assessment: Nothing to Address	
Comments: One pump was taken out and bypass pump is connected.

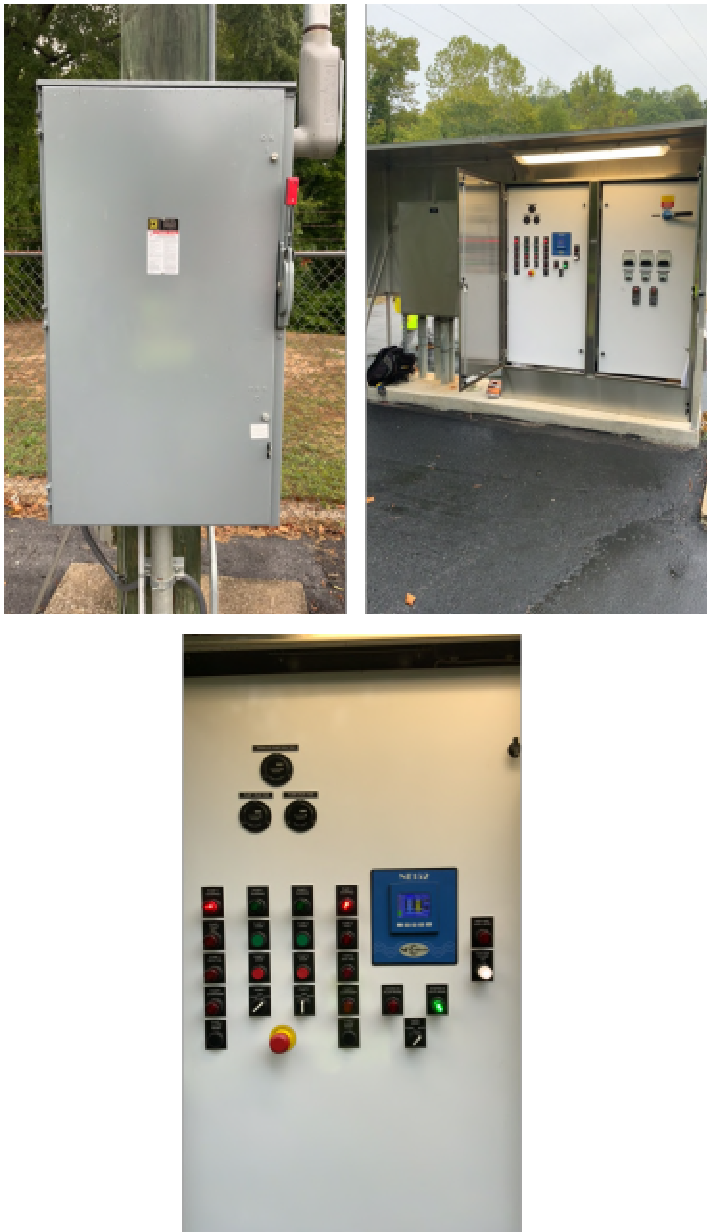
Electrical and Instrumentation Photos

Onsite Backup Generator:	Yes	WW Bypass (Suction)?:	Yes
Portable Generator Hookup?:	Yes	Control Panel and Instrumentation:	No Defects, Equipped With Current WWTa "Standard"
Onsite Backup Pumps?:	Yes	Overall Assessment:	Nothing to Address
Discharge Pipe Bypass?:	Yes		
Comments:	None
