Re: Approval of the Sanitary Sewer Evaluation/Rehabilitation Work Plan, Incident Response Plan, and the revised Sewer Overflow Response Plan
Consent Decree Case No. 1:23-cv-00225

Appendix A – SSER Basin Map

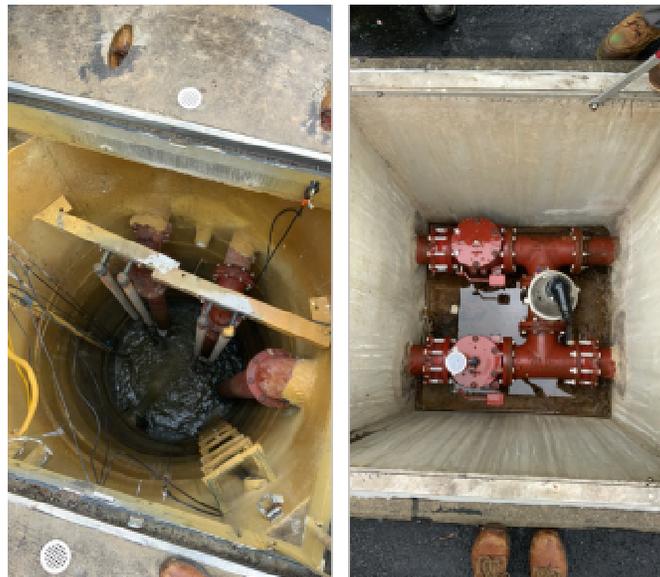
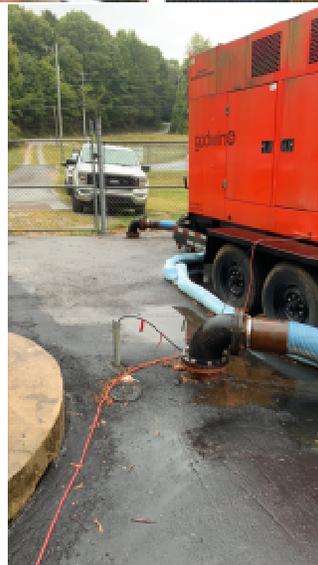
Structural/Mechanical Photos

Number of Pumps: 2	VV Supports/Guide Rails: No Defects
Pump Condition: No Defects	Onsite Water: Yes
WW Discharge Piping: No Defects	Water Working?:
WW Supports/Guide Rails: No Defects	Hose Bib Provided?: Yes
Valve Condition: Accessible, Working	Washdown Pad?: Yes
VV Discharge Piping: No Defects	Backflow Preventer?:
Overall Assessment: Nothing to Address	
Comments: One pump was taken out and bypass pump is connected.

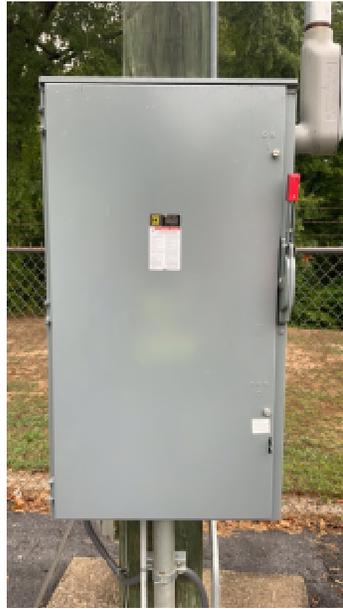
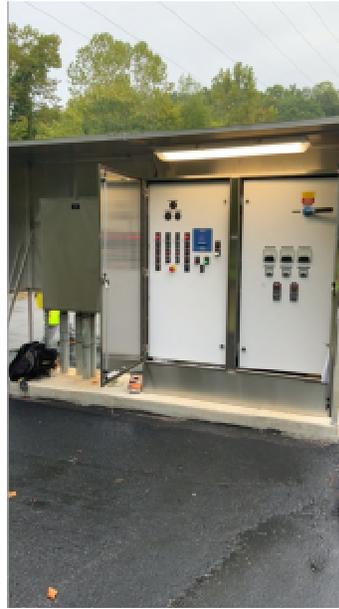
Electrical and Instrumentation Photos

Overall Assessment: Nothing to Address
